Rimkus Consulting Group, Inc.
Eight Greenway Plaza, Suite 500
Houston, TX 77046
(800) 580-3228 Telephone
(713) 623-4357 Facsimile

Re: RCG File No: 11009971
LLV Number: 0209452
VMF Location: 1530 Greensmark Drive in Houston, Texas
Subject: Final Report

Rimkus Consulting Group, Inc. was retained to examine LLV 0209452, VIN 1GBCS10E4M2908832. The fire occurred on June 13, 2016 at around 12:30 P.M. the operator of the vehicle at the time of the fire, was unavailable for interview but reportedly stated the vehicle's engine died while delivering mail on his route and backfired during subsequent attempts to restart it. Soon thereafter, smoke was observed from beneath the hood as well as flames.

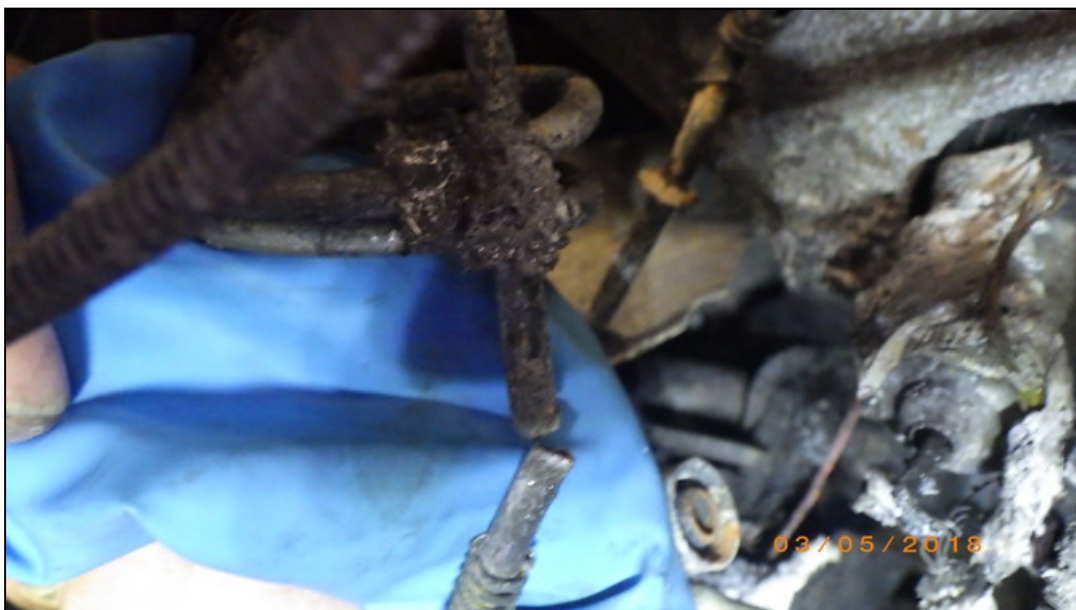
Photograph 11

The brake lines positioned on the left side of the engine sustained fire and heat damage. One brake line had been severed below the coiled area. There was charred residue inside of the tubing. The lower portion of the brake line displayed more severe damage at the break. The exhaust manifold displayed severe heat damage. The fuel filter sustained heat damage but was intact.

A view of the severed brake line.

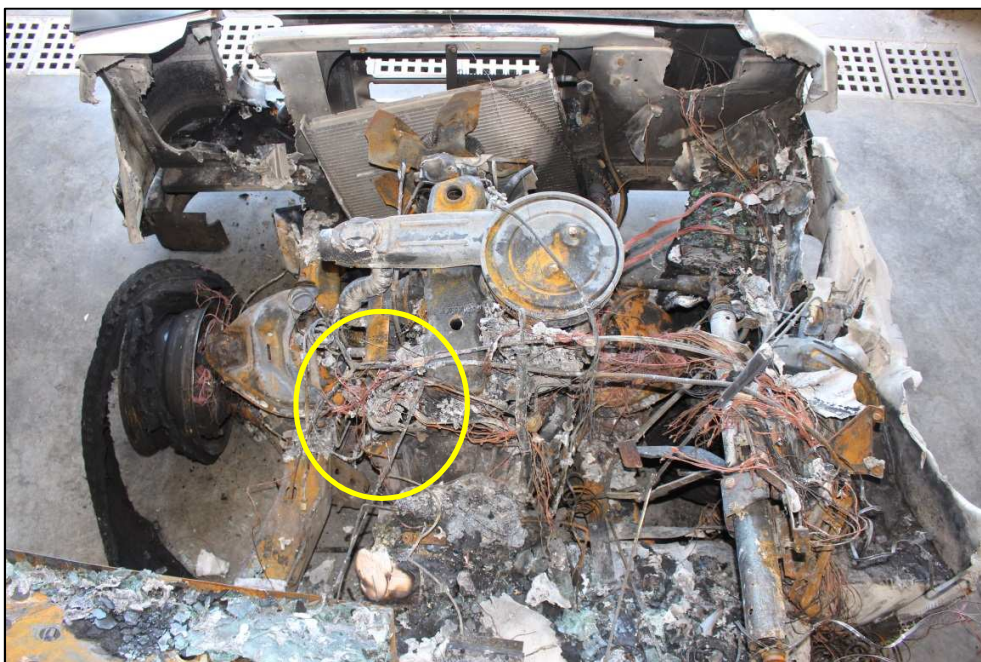
Photograph 2
View of engine compartment, front of LLV at top of photo. Origin area, yellow circle.

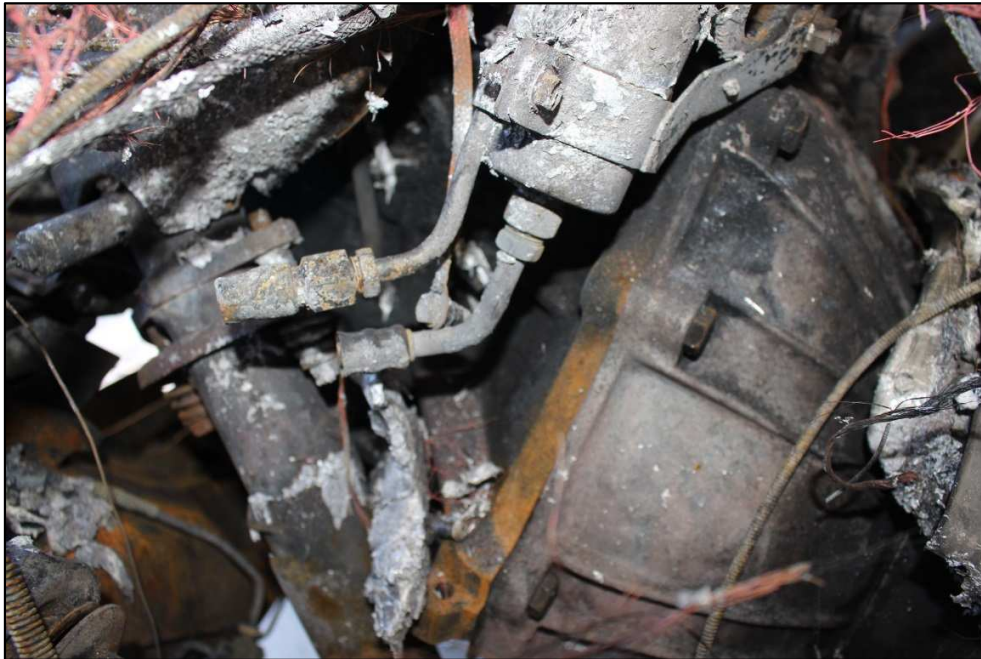
Photograph 3

Origin area. Fuel filter (top center) with rigid lines attached. Exhaust pipe (lower left).

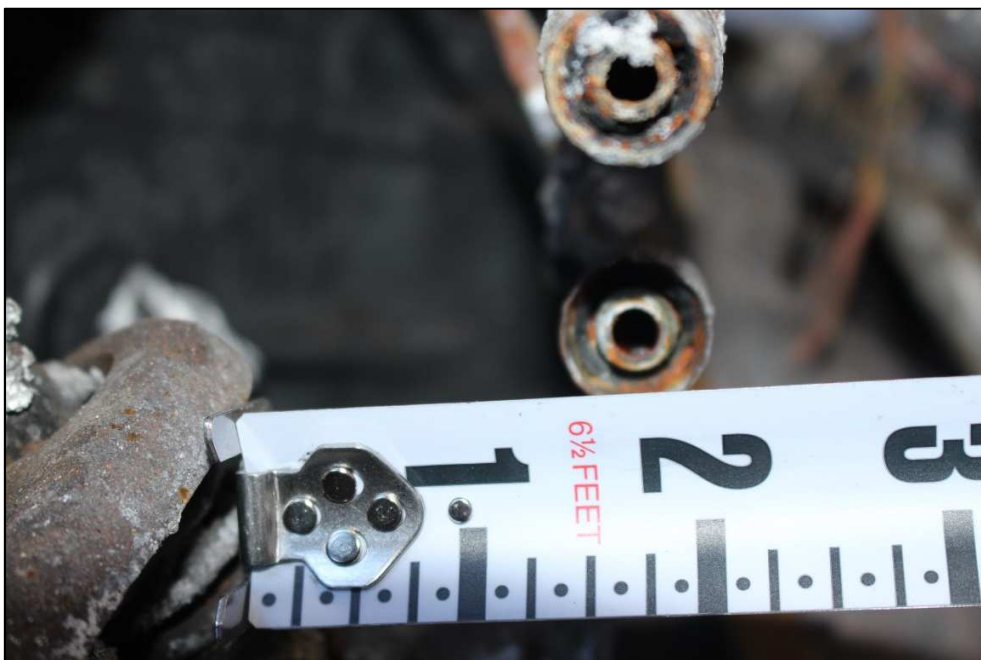
Photograph 4

Location of fuel lines (top and center) in relation to exhaust system (lower left).

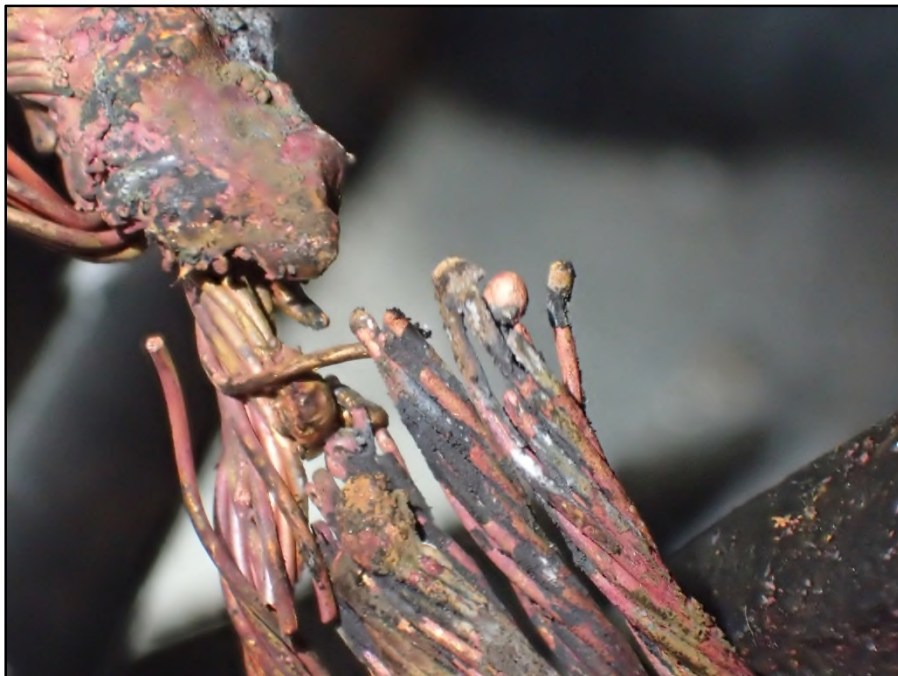
Photograph 4

Close up of adverse electrical activity on conductor.

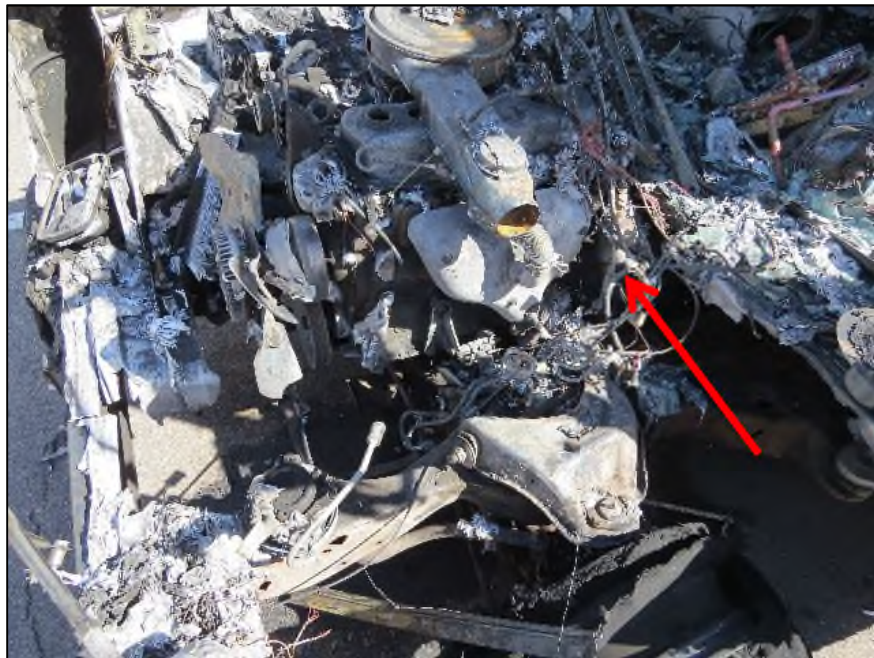
Photograph 2
Left side of engine compartment. Arrow points to fuel filter.

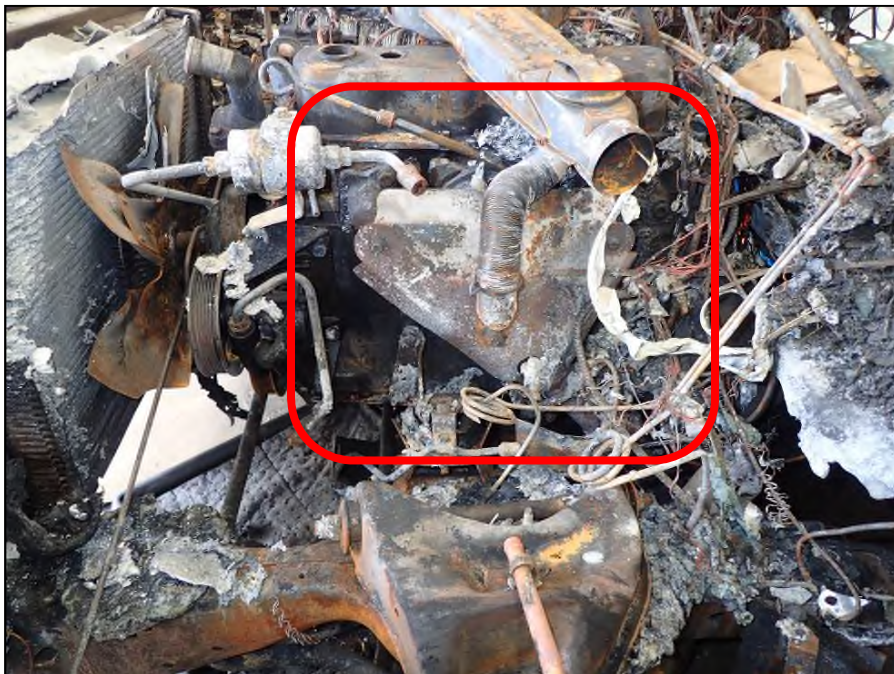
Photograph 4

Left side of the engine and area of fire origin.

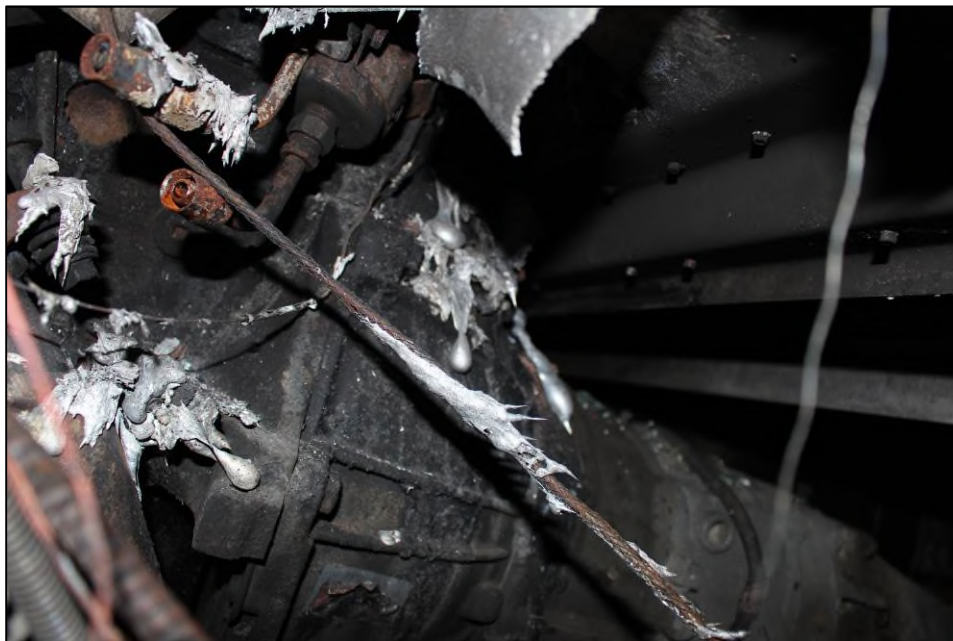
Photograph 8

Fuel filter.

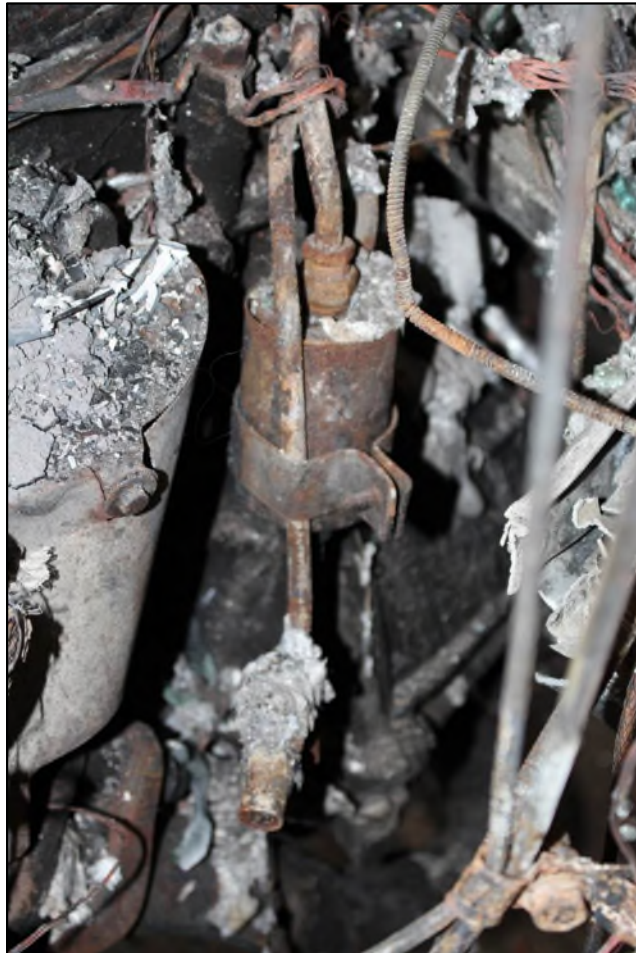
Photograph 9
Fuel filter.

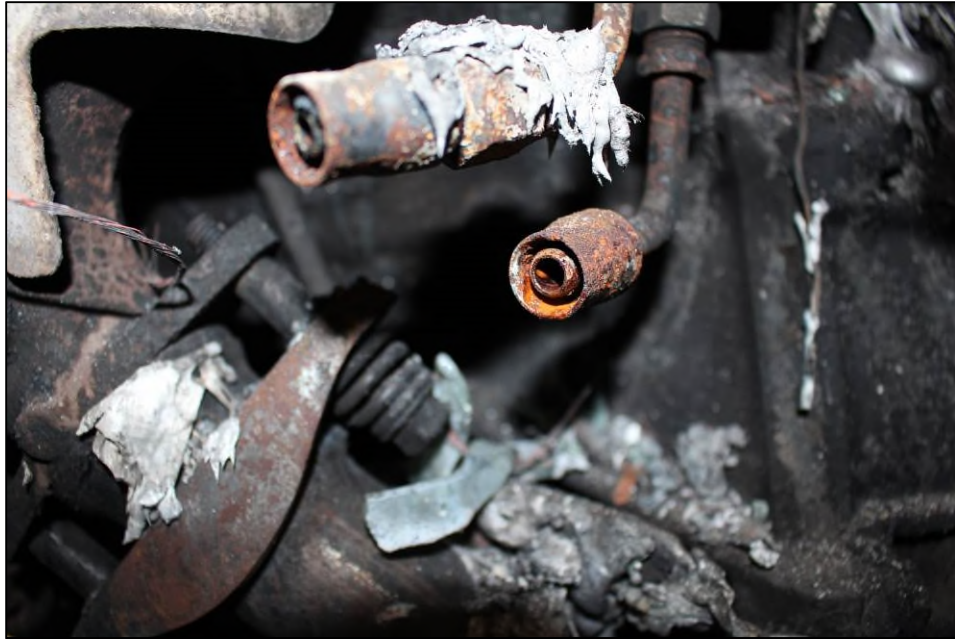
Photograph 10
Fuel line fittings.

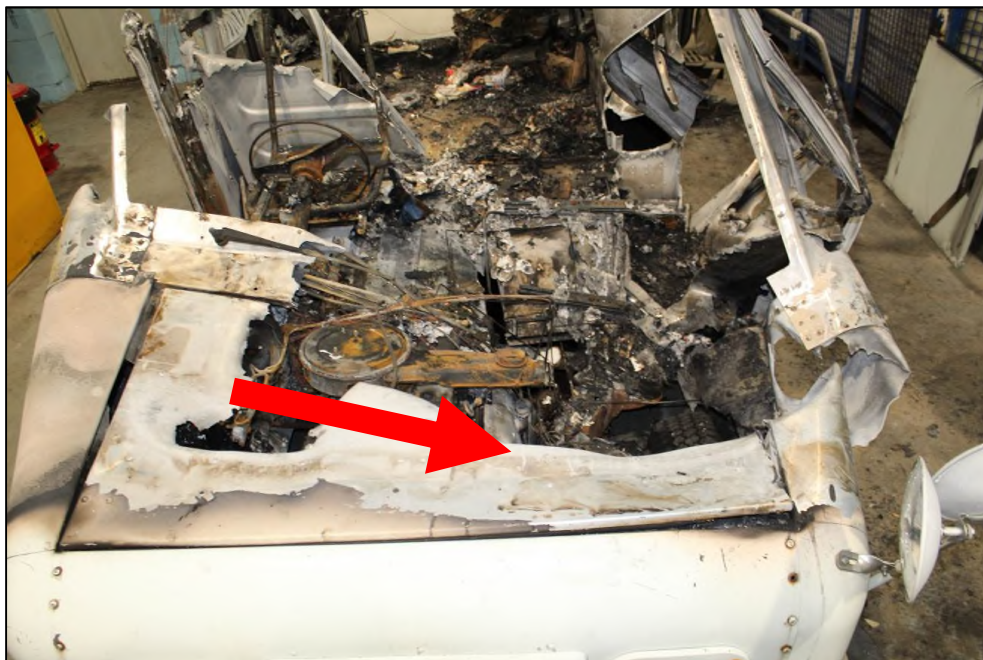
Photograph 2

Burn pattern on remains of engine hood.

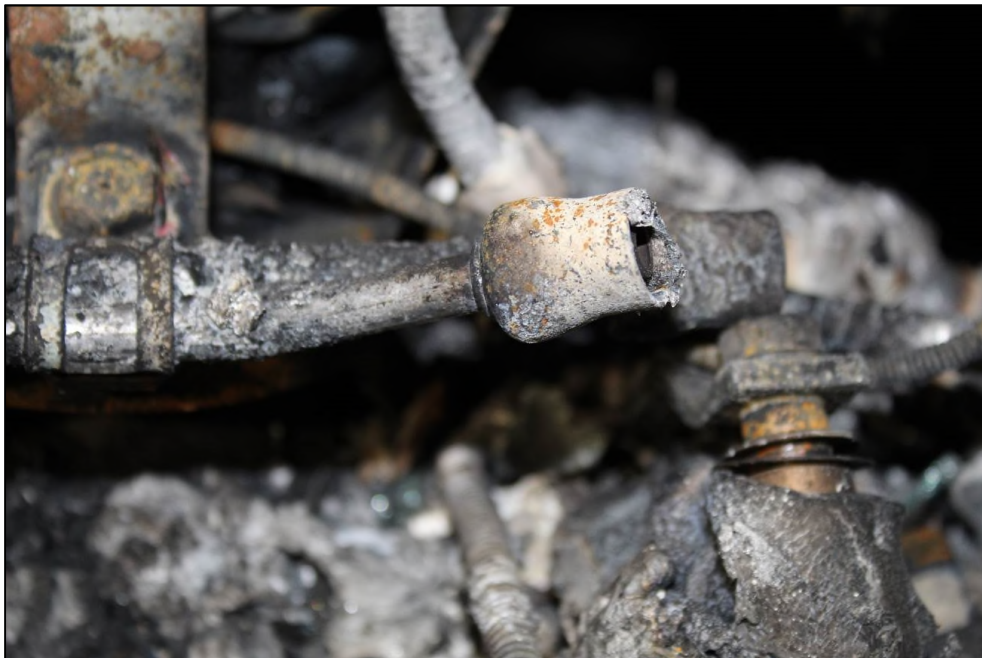
Photograph 4

Discoloration of fuel line connection on left side of engine.

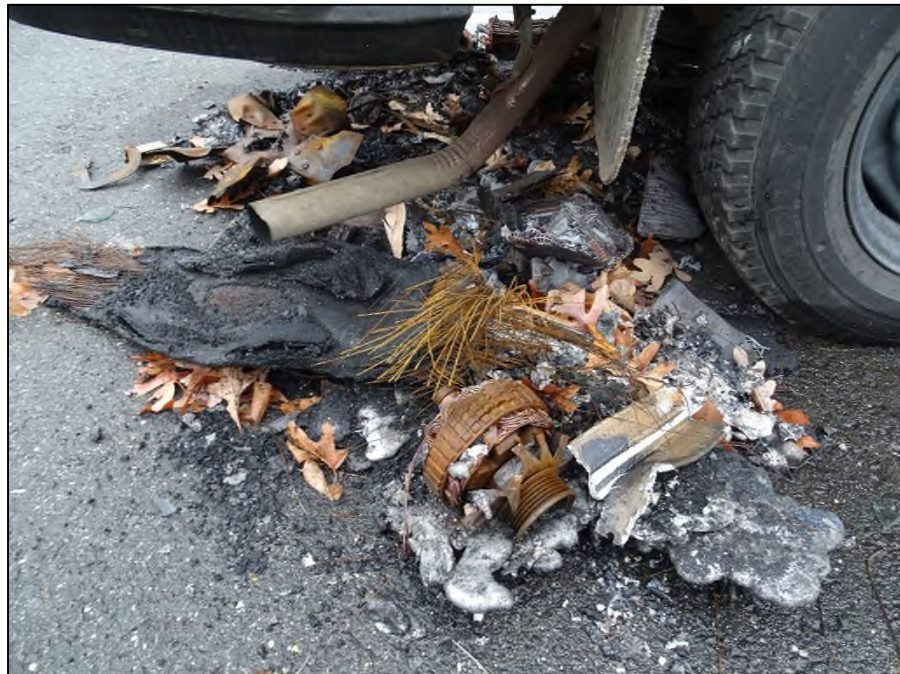
Photograph 6
Debris pile underneath LLV.

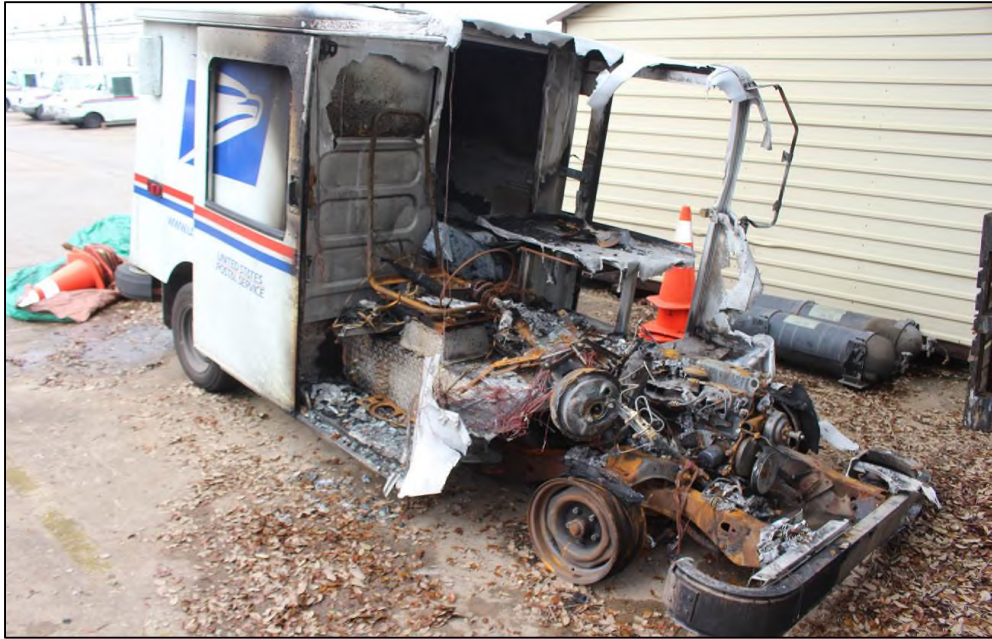
Photograph 1

Exterior view of fire-damaged remains of vehicle from front driver side.

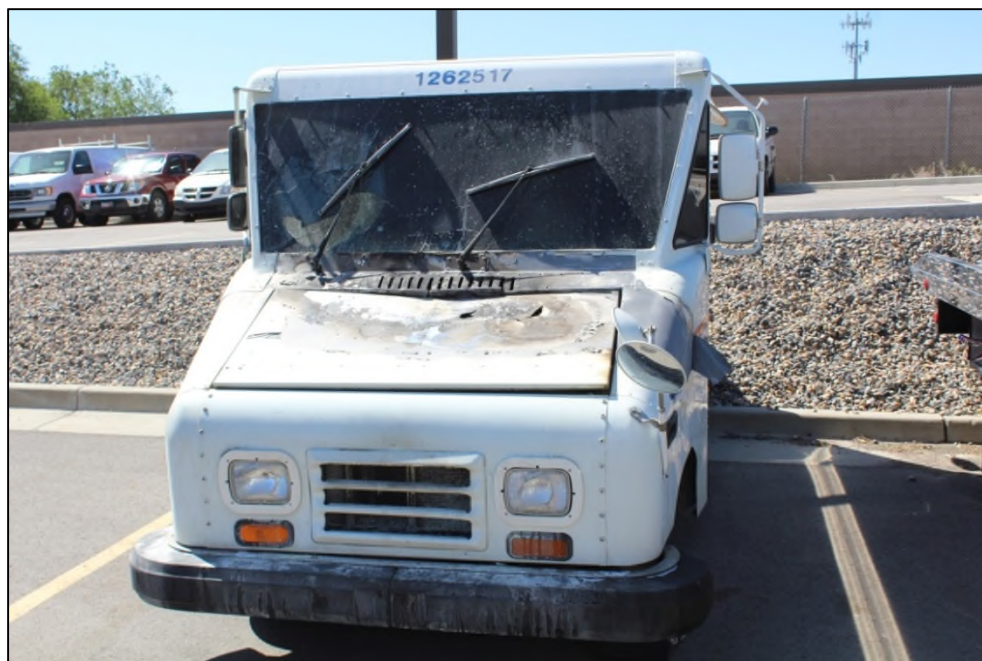
Photograph 1
Front hood of LLV.

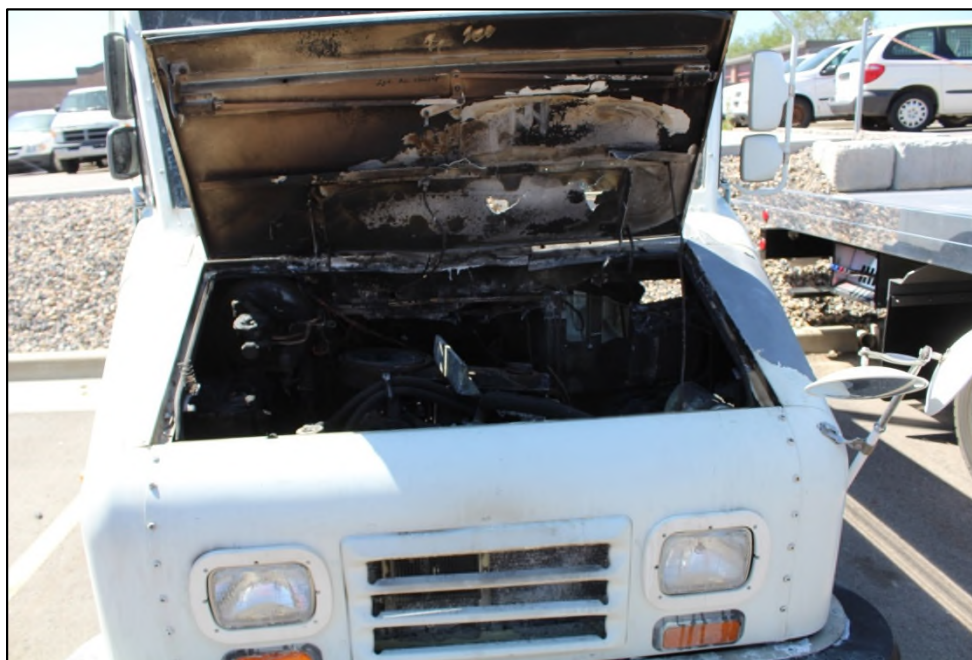
bottom of the engine. The underside of the hood above the left rear side of the engine was damaged from heat and flame. Paint on the underside of the hood and centered over the left rear of the engine had been consumed by the fire in the area of the left rear of the engine were metal fuel lines. The rubber fuel lines that were attached to these metal fuel lines had been consumed by the fire. The rubber fuel lines were located over the left rear of the engine compartment. The engine oil dip stick indicated the crankcase was full of oil. There was no indication of any oil leak from the engine. The fuel system was the GM model.

Photograph 2
Underside of hood.

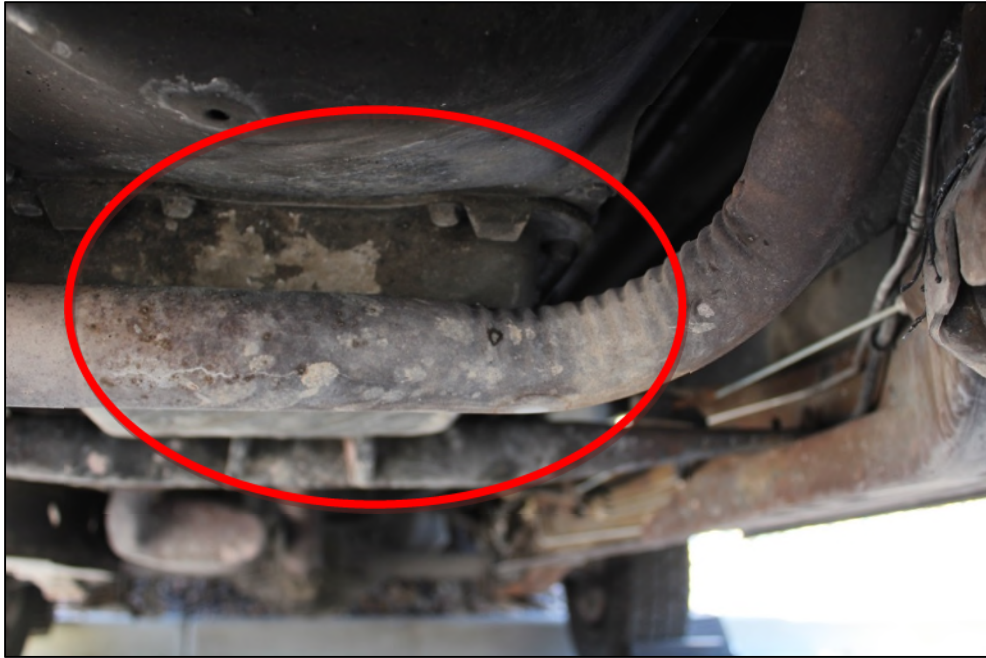
Photograph 3

The undercarriage of the LLV was examined. The exhaust pipe extended from the exhaust manifold down to the bottom of the engine and then transitioned to the right side of the engine just in front of the oil pan. The exhaust pipe was damaged from direct flame impingement along this transition. The paint on the front of the oil pan which is parallel to the exhaust pipe is burned off. At the bottom of the exhaust pipe where the transition begins, a circular pattern that is consistent with a liquid puddling and then dripping from the exhaust pipe was observed.

Burn pattern on exhaust pipe and oil pan.

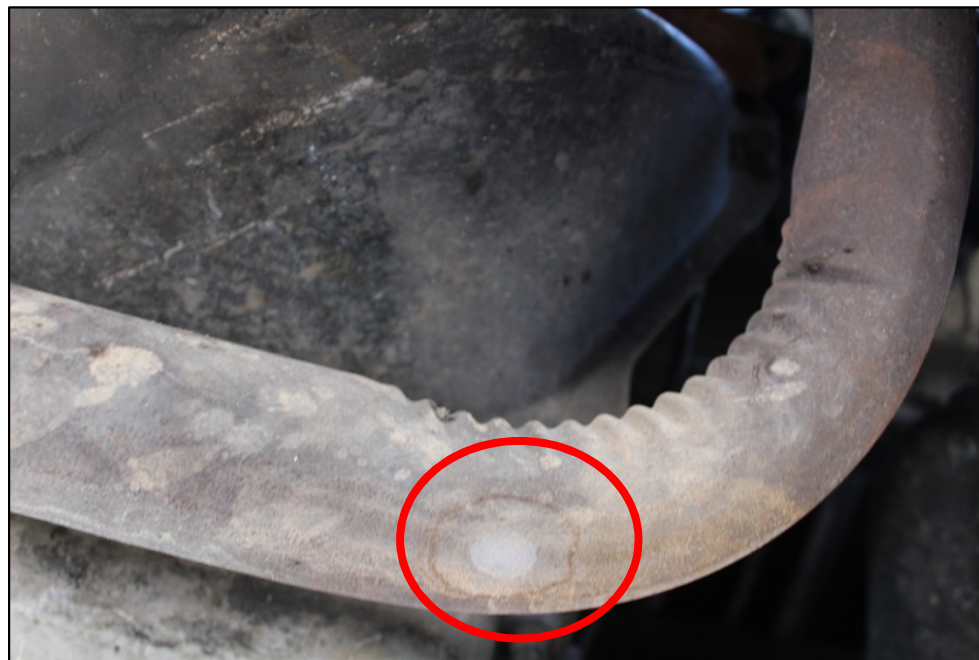
Photograph 4

Liquid pooling and dripping pattern on bottom of exhaust pipe.

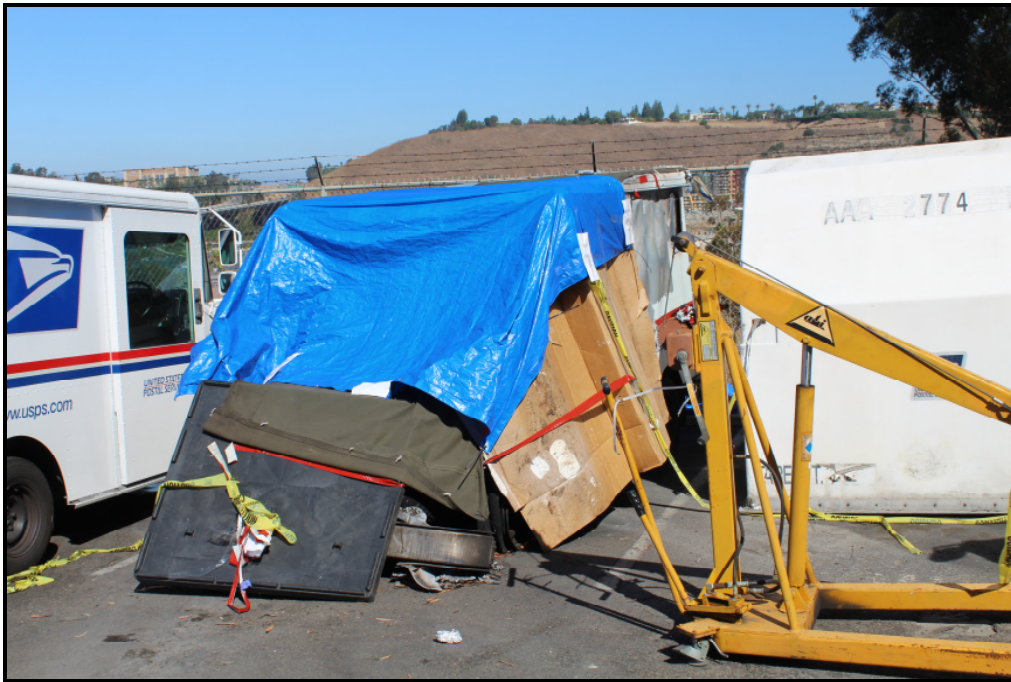
Photograph 1

Looking northwest- status of vehicle on date of inspection.

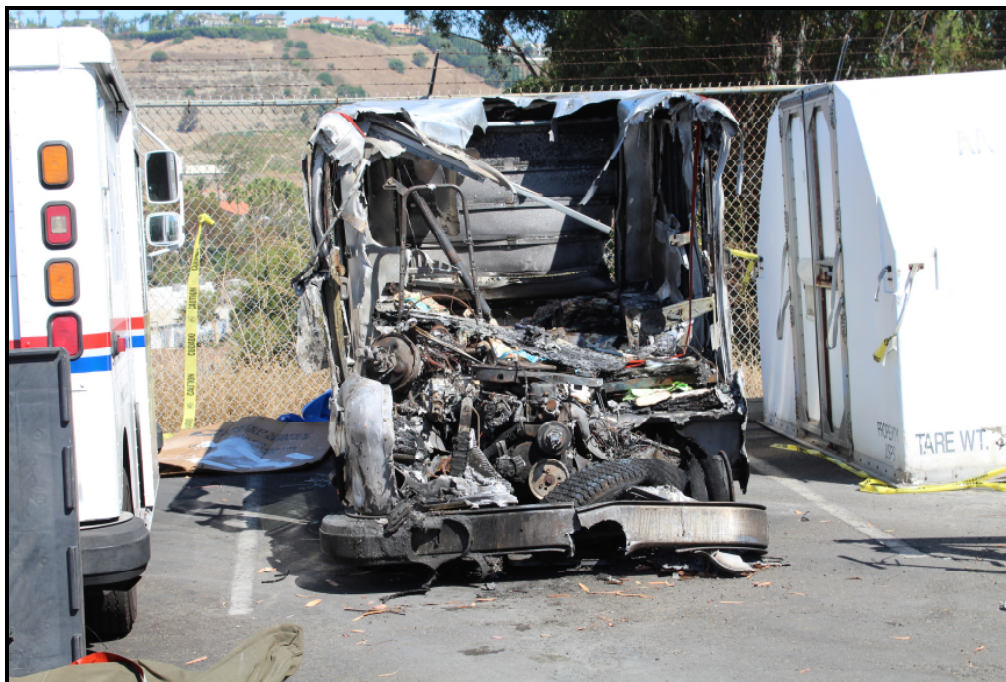
Photograph 2

Looking northwest- remains of vehicle after coverings removed.

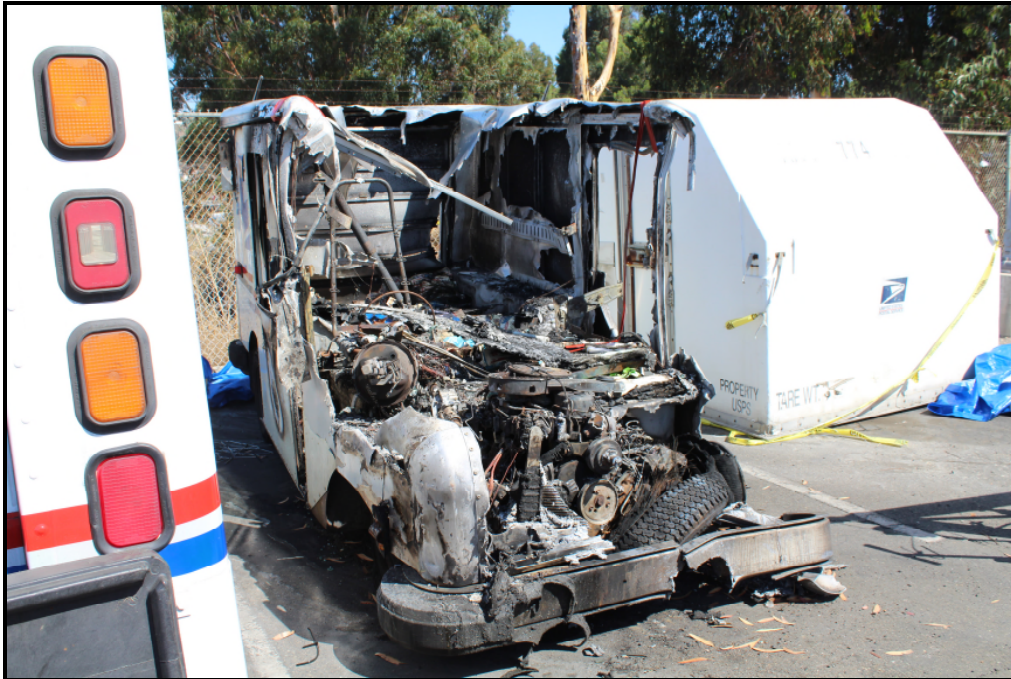
Photograph 3

Front and ride side of vehicle.

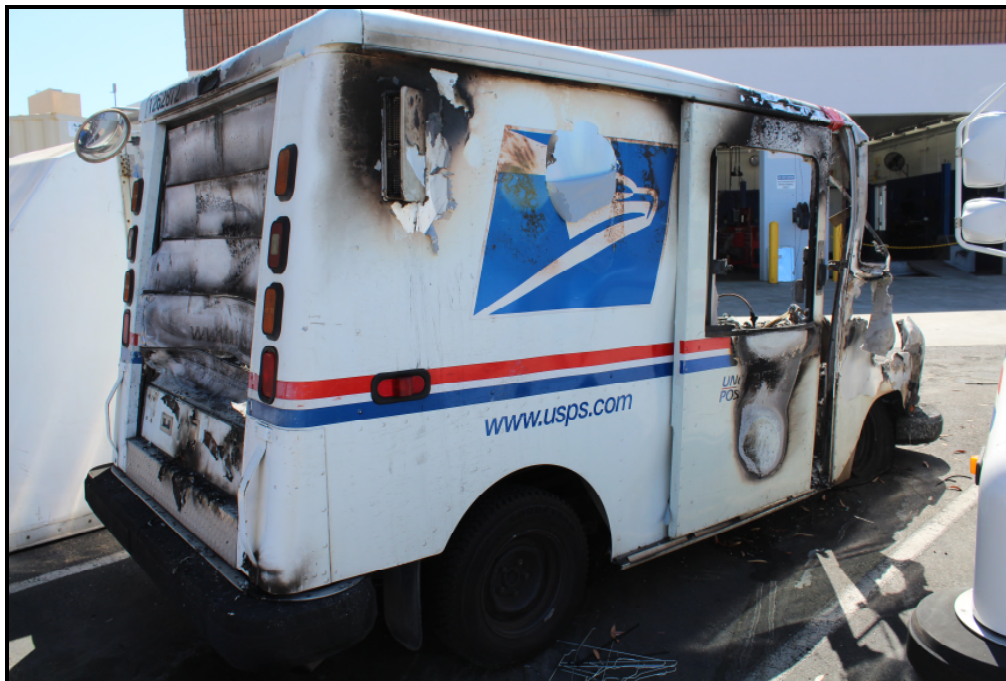
Photograph 4

Right side and rear of vehicle.

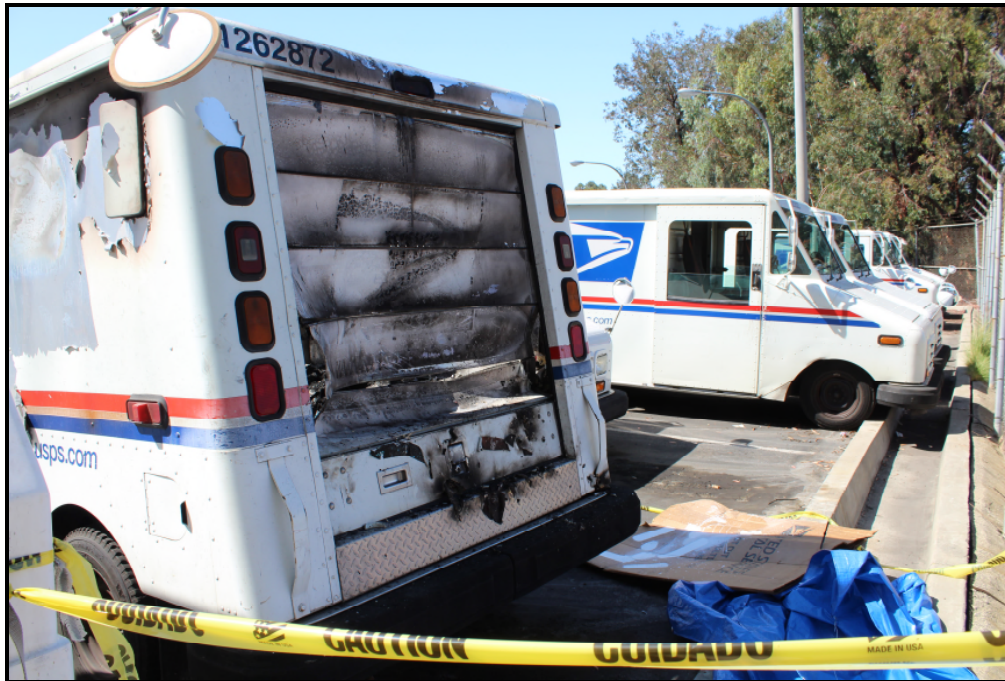
Photograph 5

Rear of vehicle showing damage to door and fire patterns.

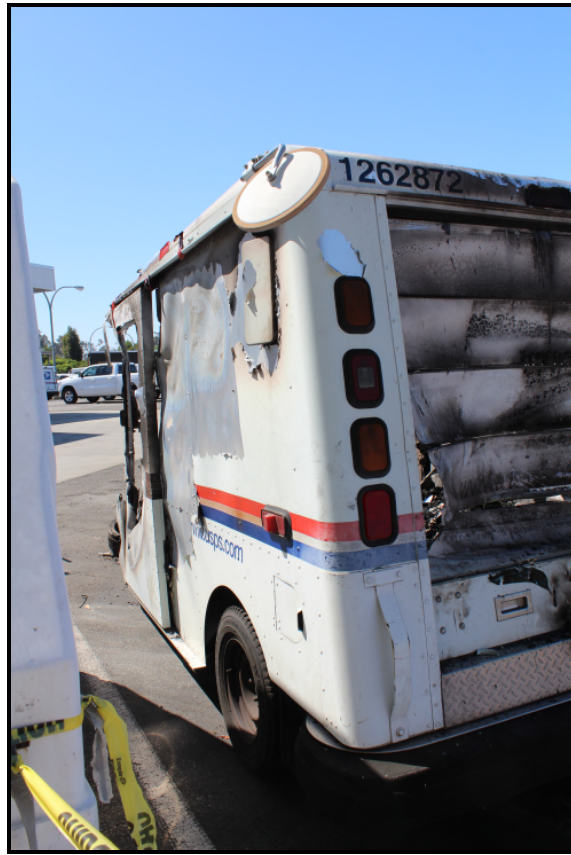
Photograph 6

Rear door and rear of left side of vehicle.

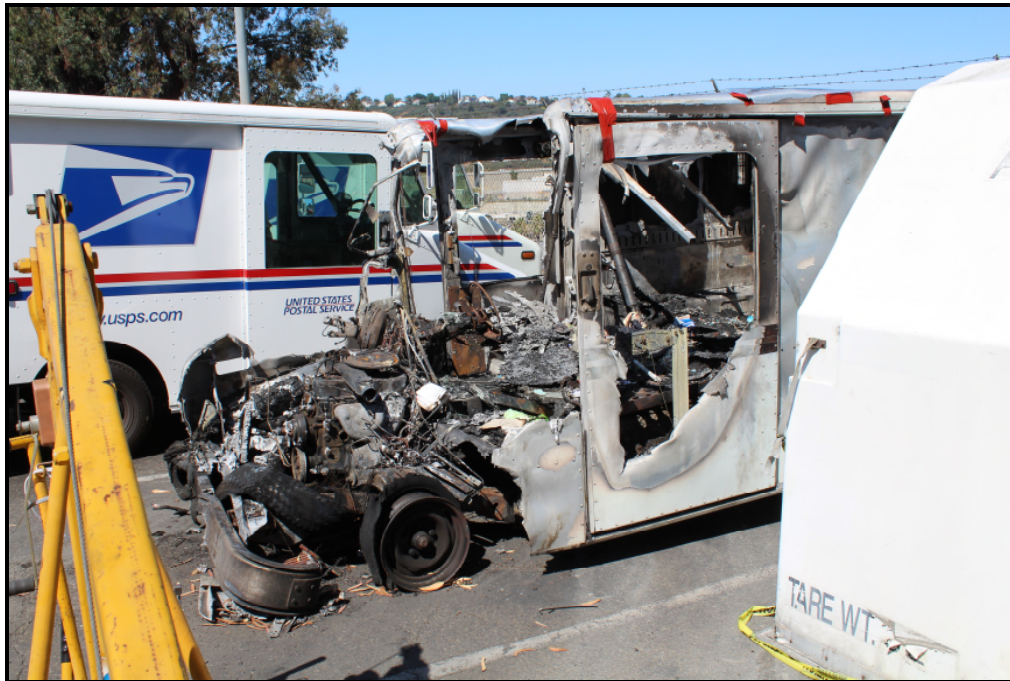
Photograph 7

Forward portion of left side and engine compartment of vehicle.

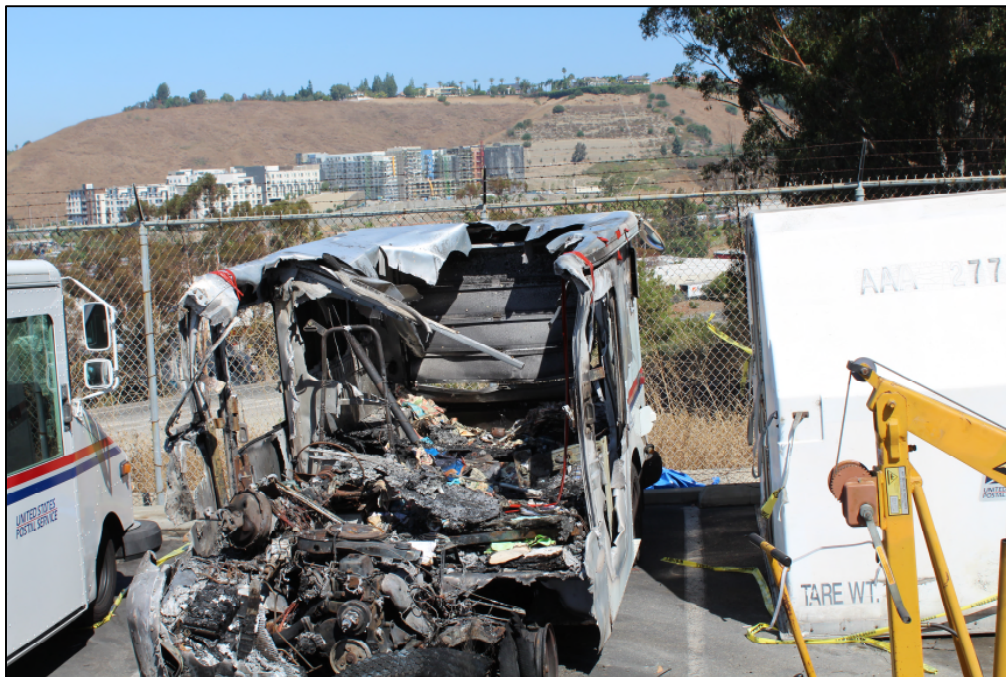
Photograph 8

Remains of roof and interior compartments of vehicle.

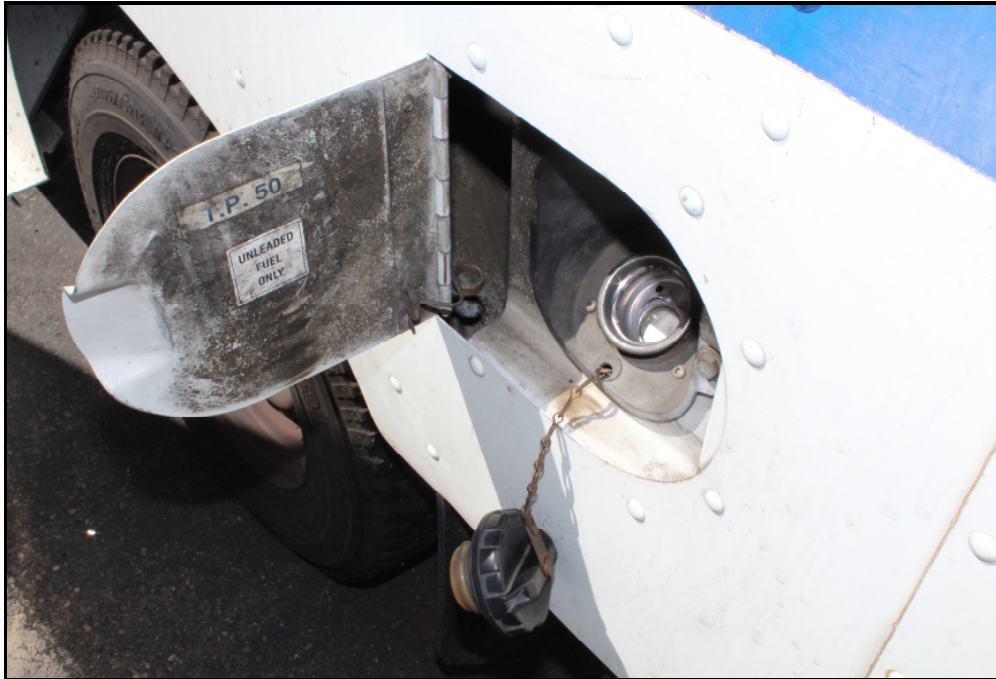
Photograph 9

Gas access door, gas cap, and gas spout of vehicle.

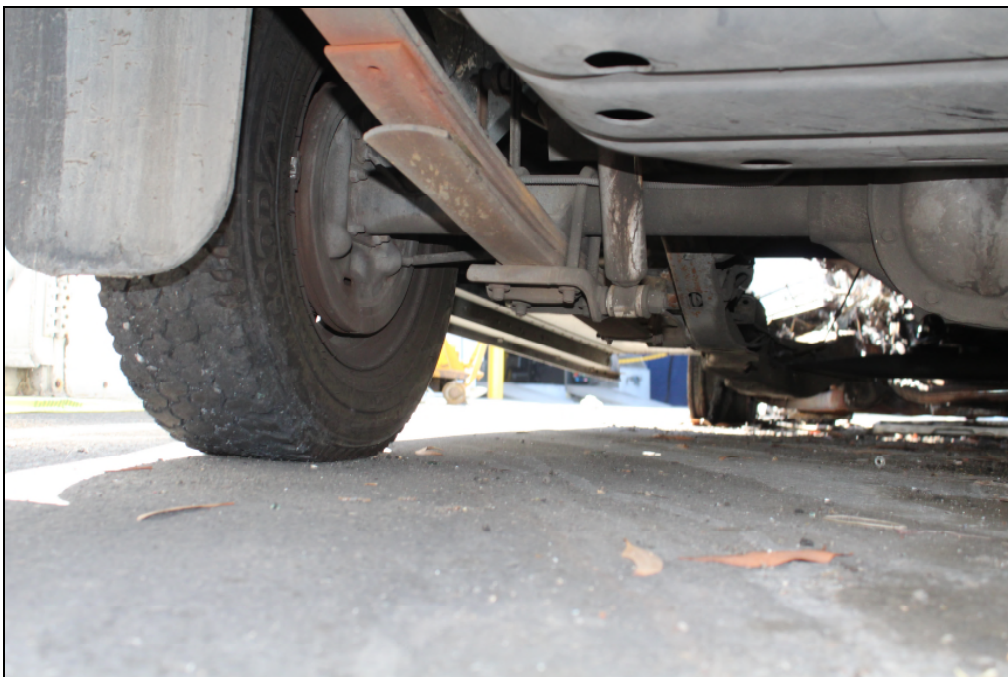
Photograph 10

L-rear undercarriage area showing general oxidation to leaf springs.

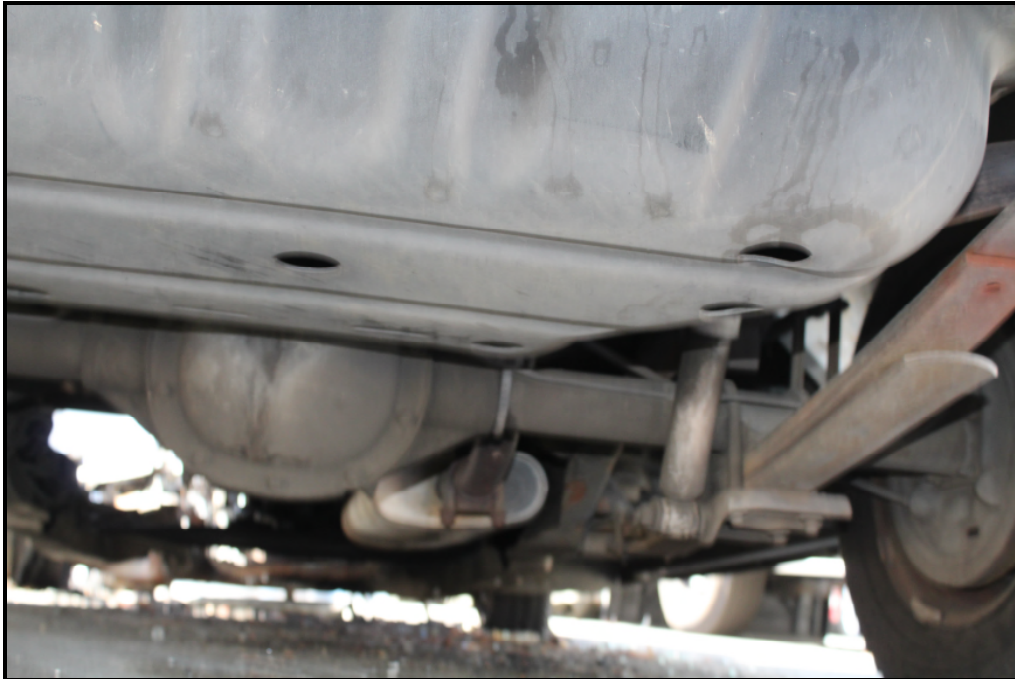
Photograph 11

R-rear undercarriage area showing general oxidation to leaf springs.

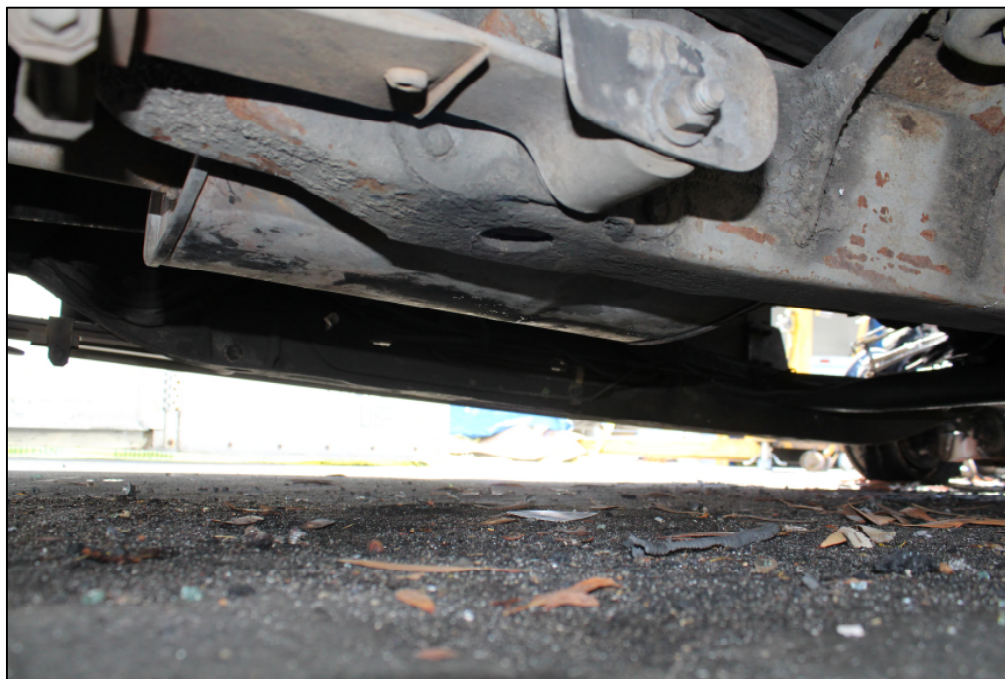
Photograph 12

Middle area of the undercarriage showing some oxidation under vehicle.

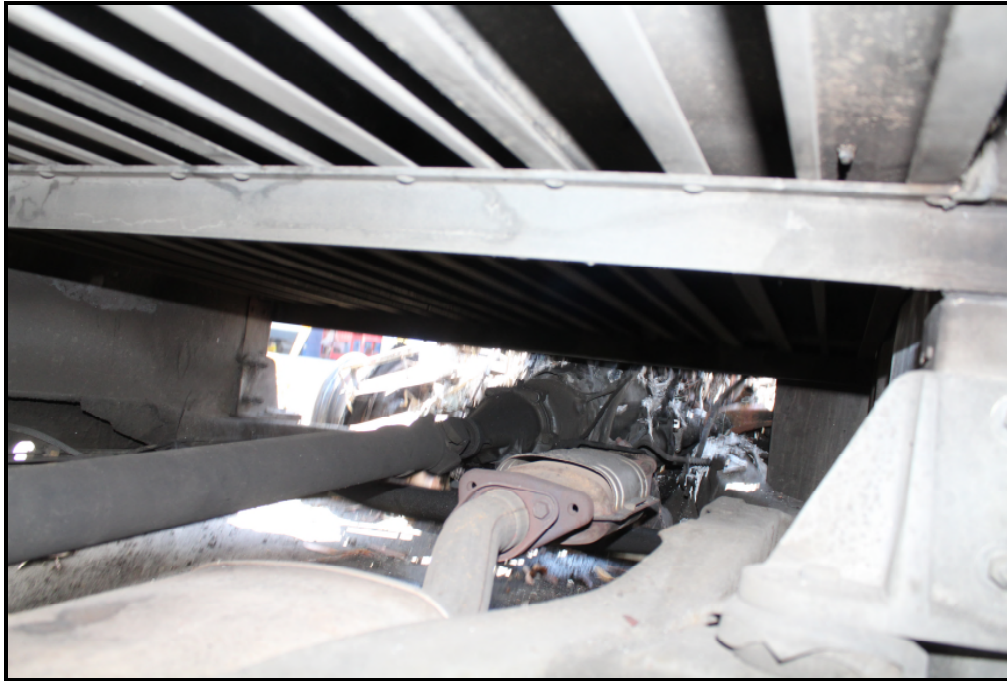
Photograph 13

Front area of undercarriage, flooring support, exhaust, and drive train systems.

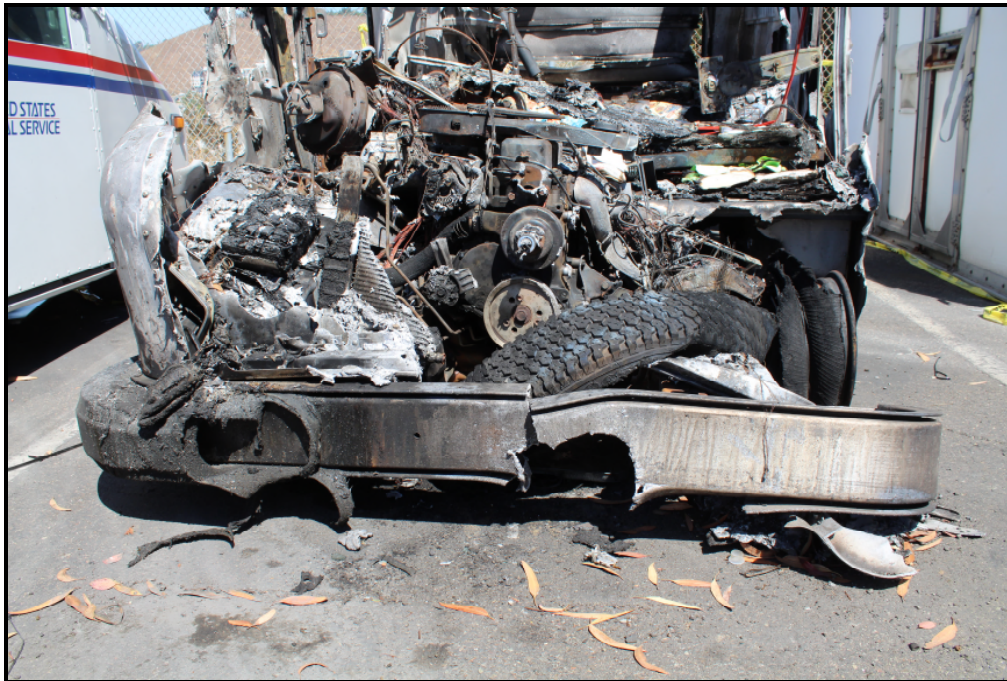
Photograph 14

Remains of engine compartment, front bumper, and driver interior.

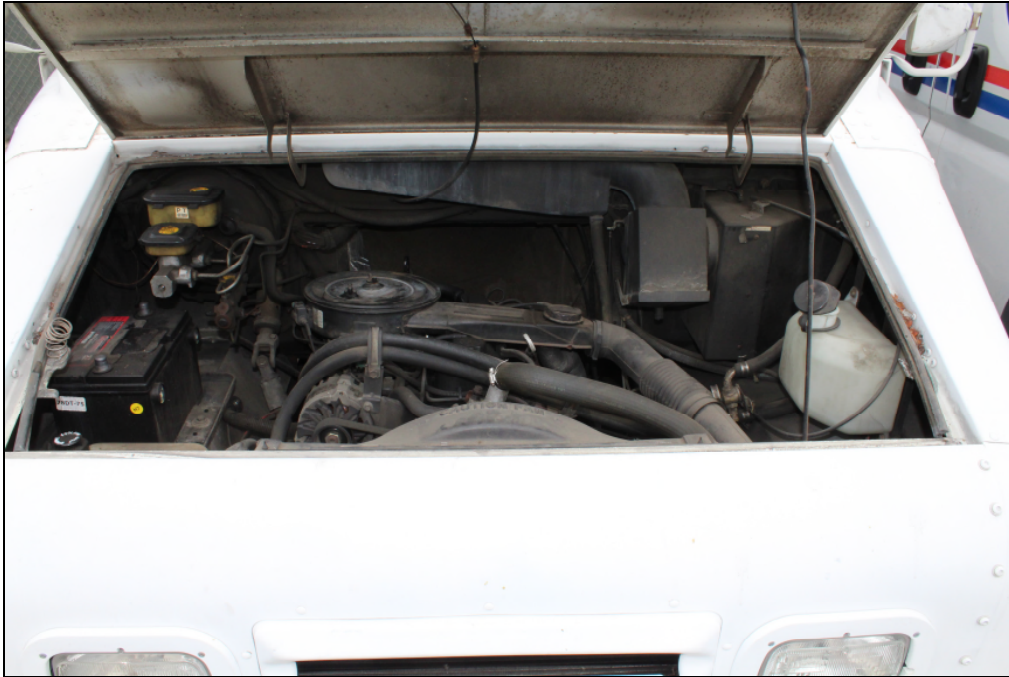
Photograph 15

Comparative photo of same vehicle year, type of engine, compartment layout.
